A DEMONSTRATION PROJECT BY

The Regional Municipality of Niagara

CRACK AND SEAT NIAGARA ROAD 1 (DOMINION
Town of Fort Erie

in co-operation with the
Ministry of Transportation of Ontario

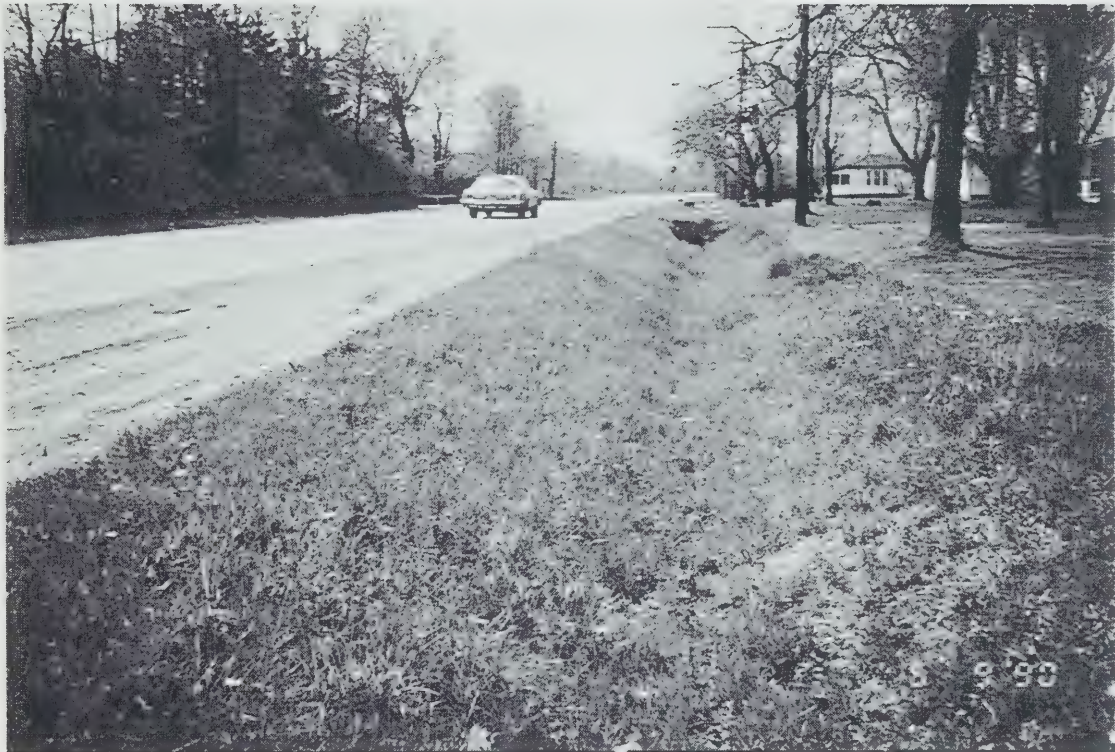
distances up to 18 metres (60 feet) apart. The original concrete roadway was constructed directly on the sub-grade with drainage provided by 60 centimetre (2 feet) deep roadside ditches for most of its length. (P1)

P1 TYPICAL ROADSIDE DRAINAGE DITCH

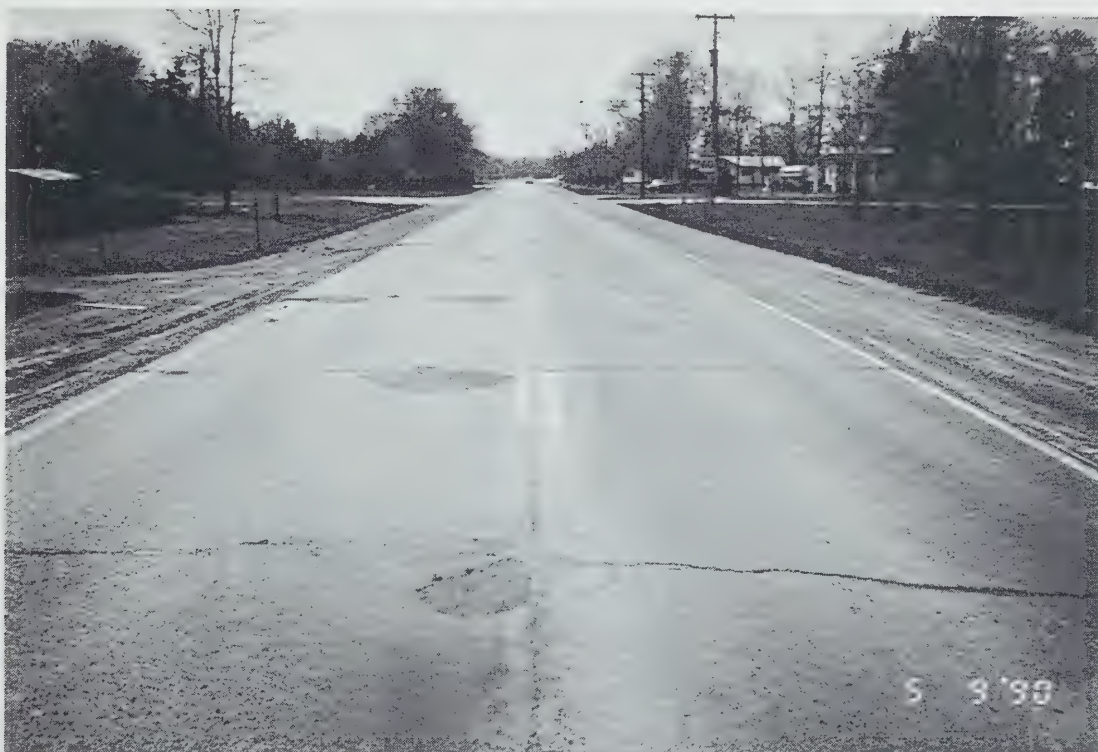
Over the years, through slab movement, transverse cracking of the concrete pavement had developed at intervals of between 1 1/2 metres (5 feet) and 4 1/2 metres (15 feet) apart. (P2) This cracking and the centreline construction joint crack then reflected through subsequent layers of asphalt overlay. (P3,4)

P2 TYPICAL CRACKING PATTERN

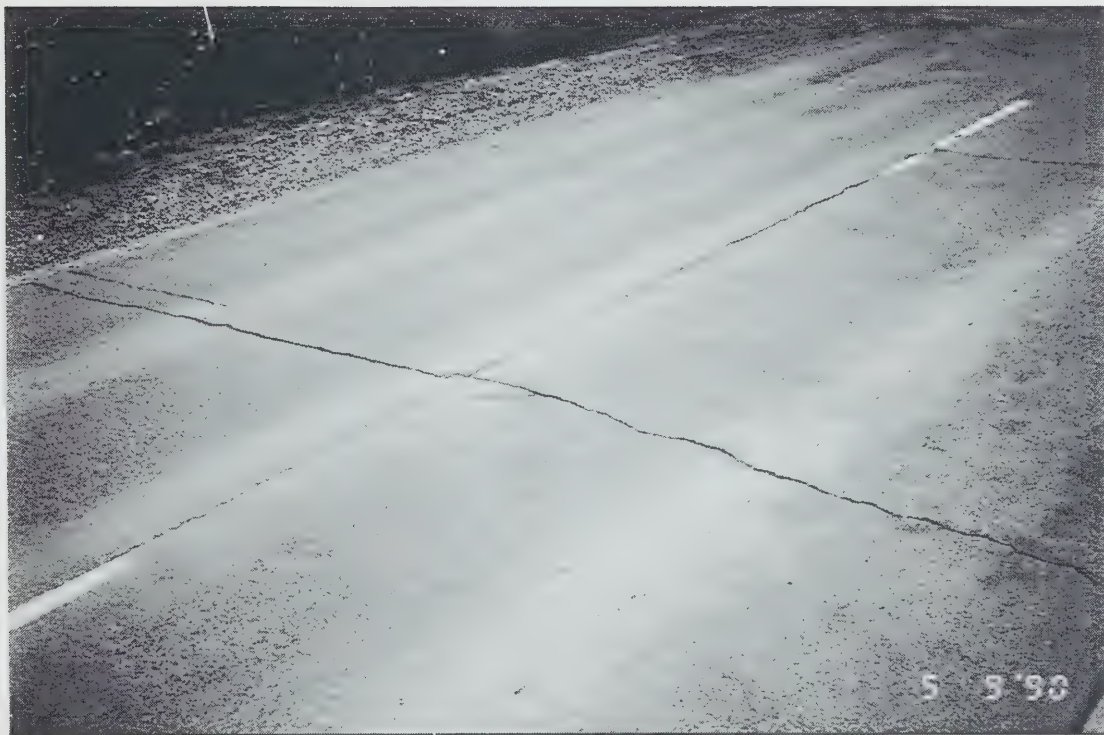
P3 TYPICAL TRANSVERSE CRACK AND CENTRELINE
CONSTRUCTION JOINT
REFLECTED THROUGH ASPHALT OVERLAY

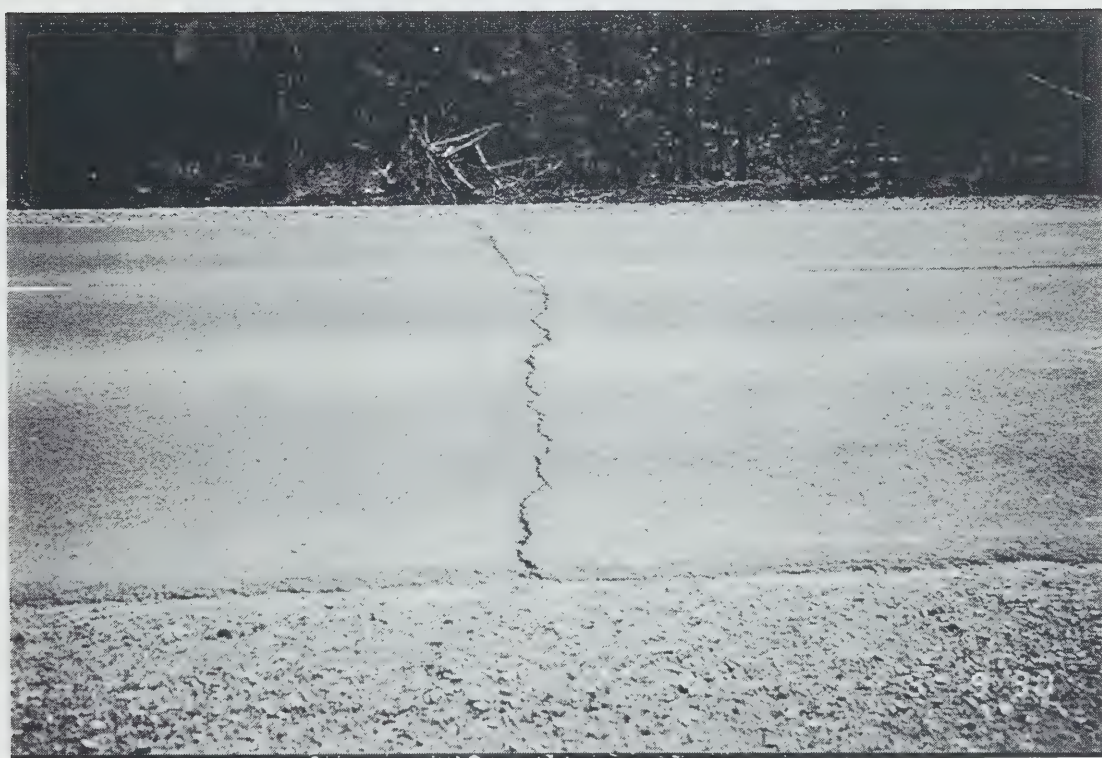
P4 TYPICAL TRANSVERSE CRACK
REFLECTED THROUGH ASPHALT OVERLAY

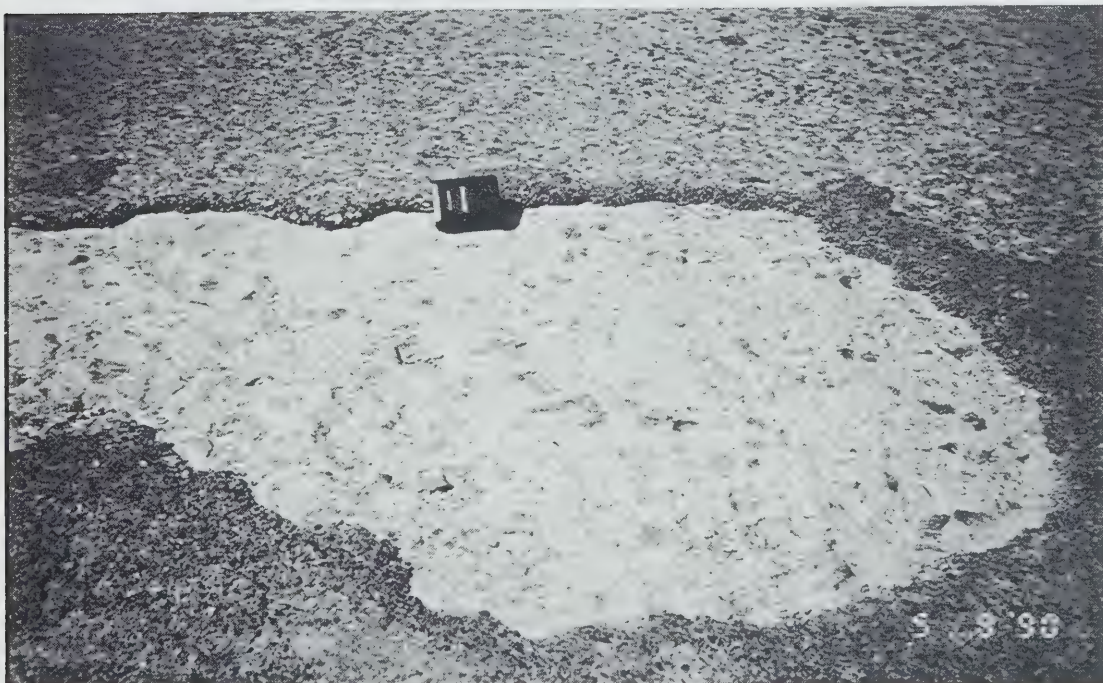
The asphalt overlay of the concrete pavement varied from a thin layer of surface treatment to several inches of hot mix overlay. In some areas, the concrete roadway was visible where the surface treatment had worn. (P5)

P5 EXPOSED CONCRETE AT SURFACE TREATMENT

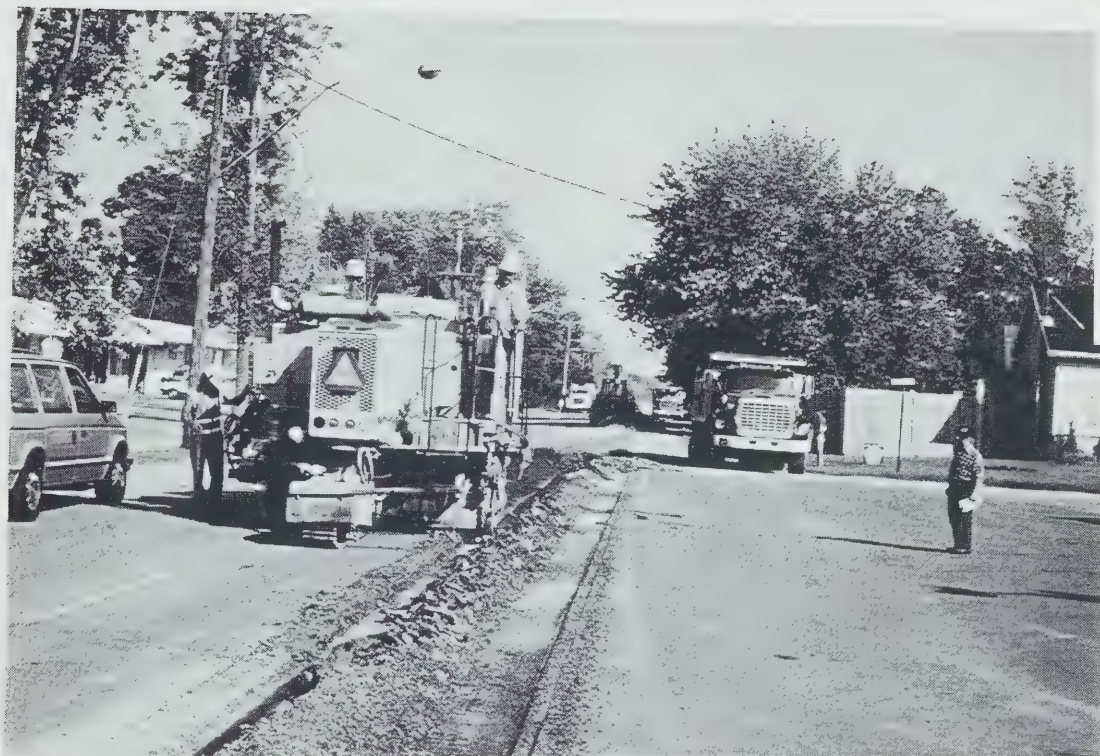
P6 ASPHALT MILLING OPERATION IN PROGRESS

Initially, some consideration was given to attempting the crack and seating operation without removing the thin overlay of surface treatment. However, leaving the overlay in place would prevent a thorough inspection of the underlying concrete pavement and could possibly act as a shock absorber during the cracking process and, therefore, it was decided to remove all asphalt overlays completely. (P6)

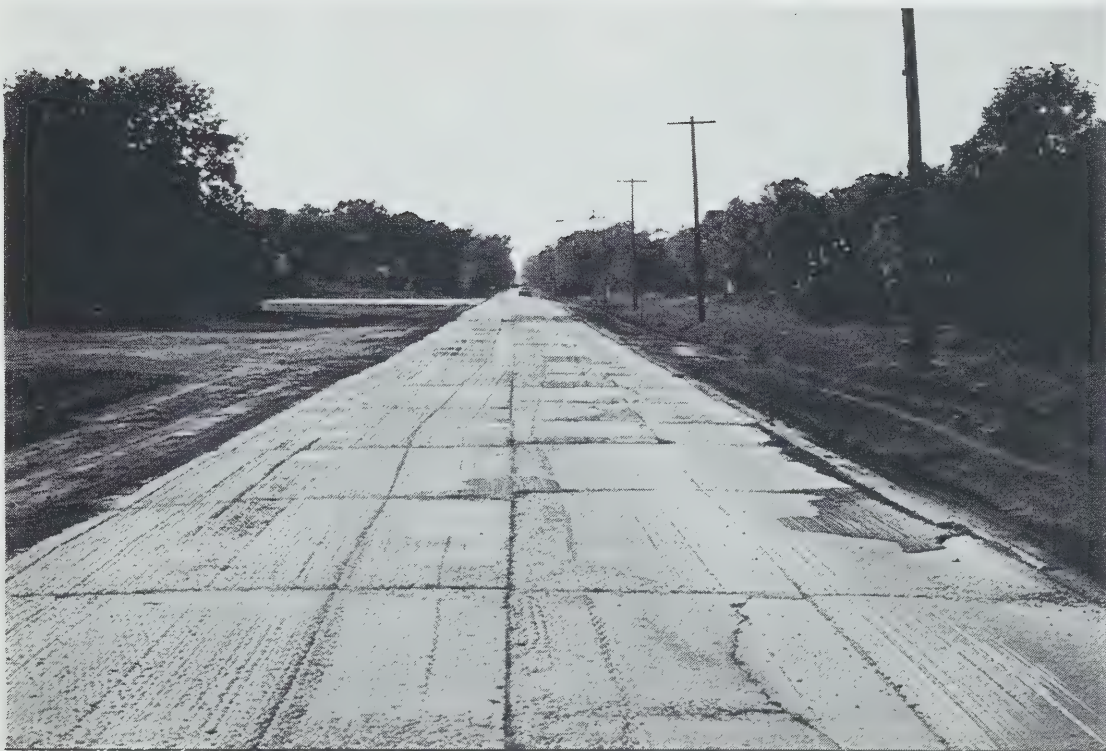
Milling operations commenced on September 27, 1990 and were completed on September 29, 1990. (P7)

P7 DOMINION ROAD AFTER ASPHALT MILLING

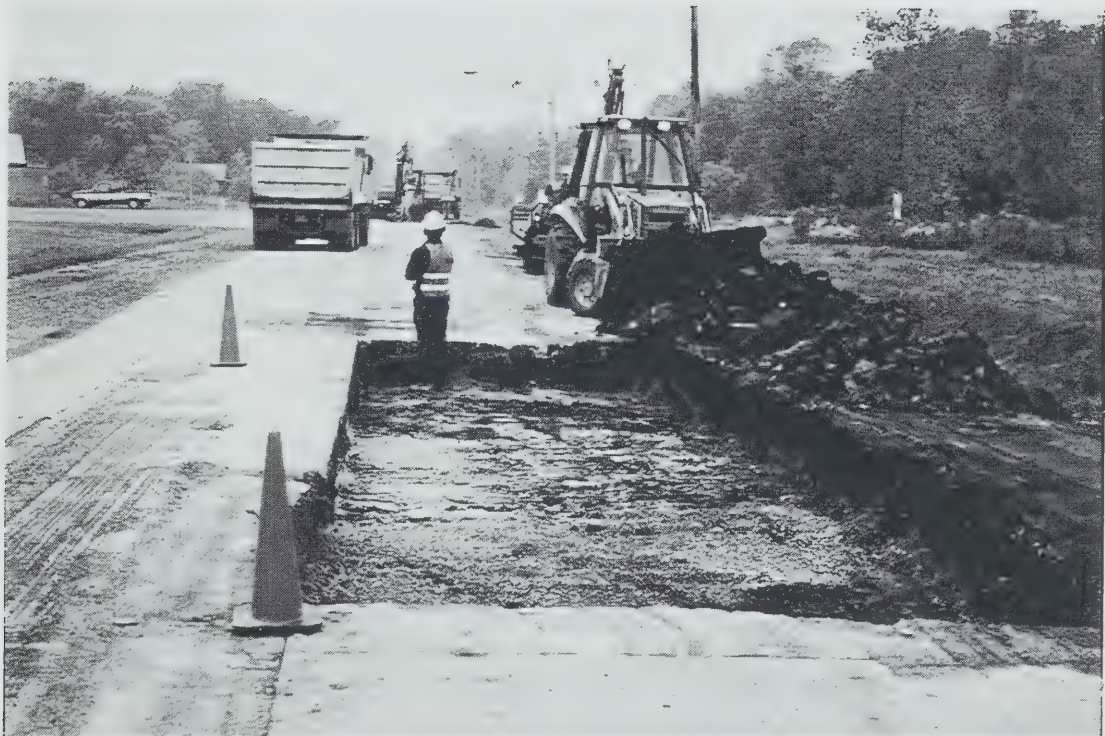
P8 AREA OF CONCRETE REMOVAL
PRIOR TO FULL DEPTH ASPHALT REPAIR
(AFTER MILLING)

Several small areas of severely deteriorated concrete were removed and replaced with full depth base asphalt (HL-8). (P8)

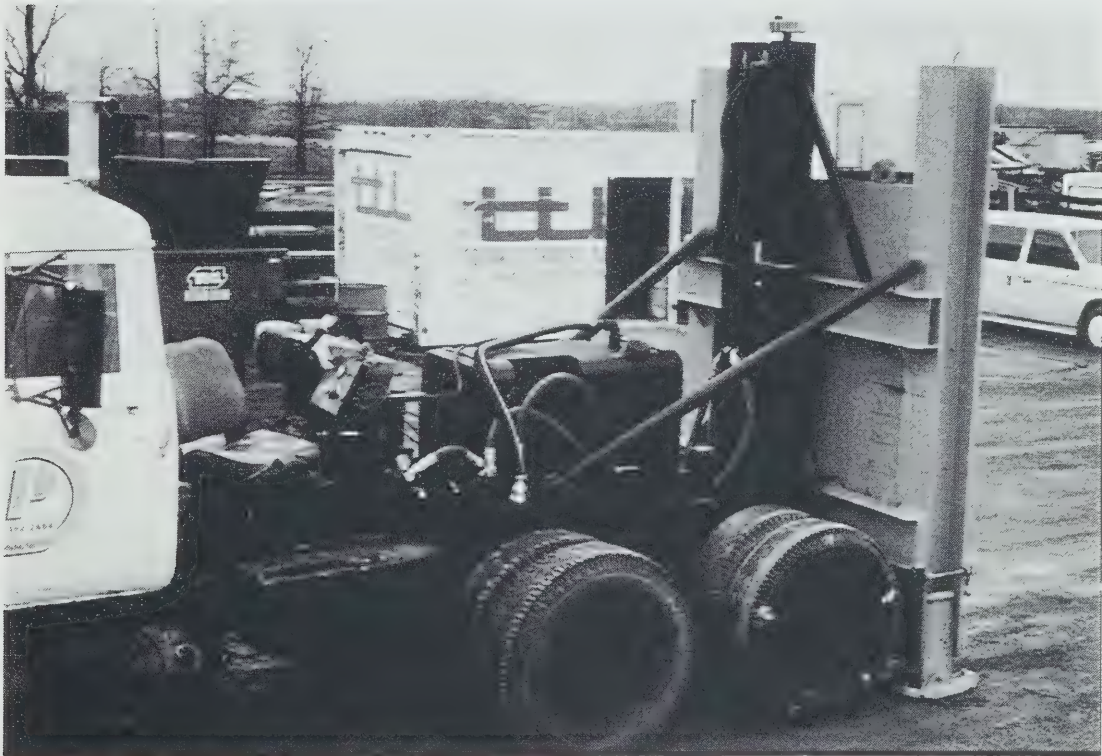
The cracking operation was carried out using a guillotine hammer type breaker (P9) mounted on the rear of a International cab and chassis. The guillotine hammer measured approximately two metres in width and weighted approximately eight tonnes. The striking face of the hammer was constructed out of a piece of railroad steel measuring approximately 7.5 centimetres (3 inches) across the face. On to this 2.5 centimetre (1 inch) square iron bar was welded to concentrate the impact on the concrete pavement. (P10)

P9 GUILLOTINE HAMMER-TYPE BREAKER

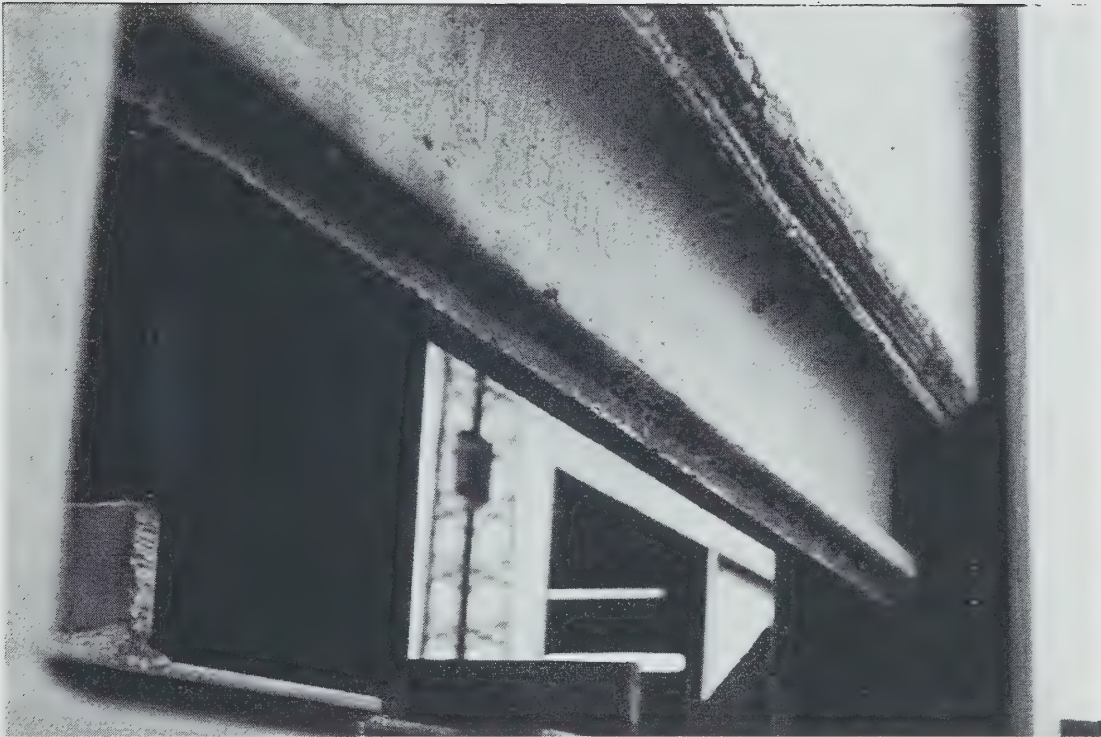
P10 STRIKING SURFACE OF GUILLOTINE HAMMER

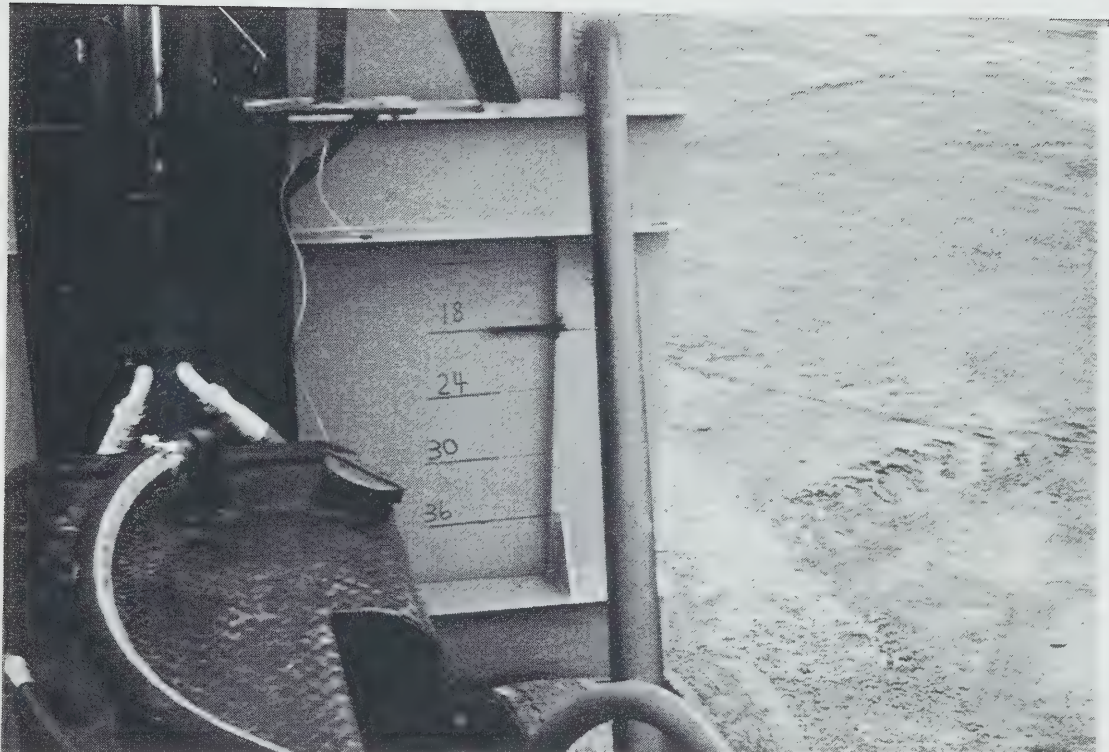
Through trial and error, it was determined that the best cracking resulted from raising the hammer approximately 45 centimetres (18 inches) above the roadway and dropping it at intervals of 45 - 60 centimetres (18 - 24 inches) along the pavement. (Pl1) In most instances, two passes were made in each lane of the roadway. One pass was made with the edge of the hammer touching the centreline construction joint and one pass with the edge of the hammer at the outside edge of the roadway adjacent to the shoulder. Every attempt was made to line up the second drop of the hammer directly opposite the first drop.

P11 INDICATES HEIGHT OF HAMMER FACE ABOVE PAVEMENT

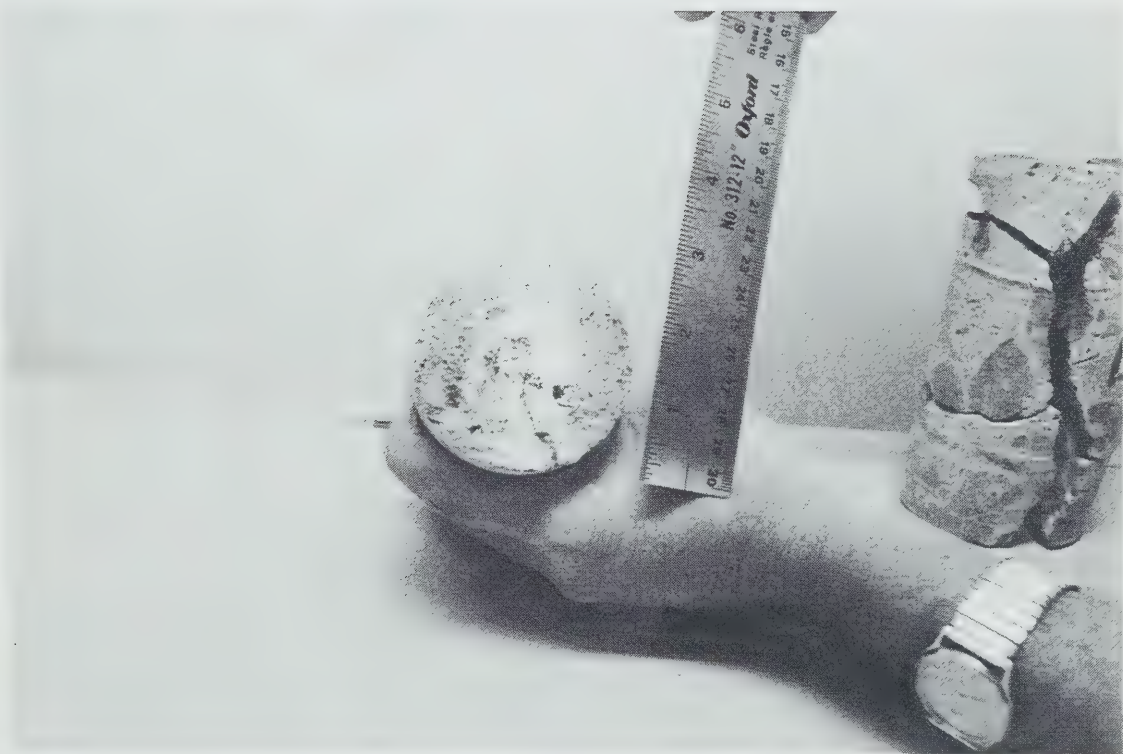
The resultant cracking of the concrete was difficult to observe. (Pl2) The cracks tended to be hairline and due to the roughness of the concrete in some areas (caused by the milling operation) the cracks were difficult to locate. Wetting of the surface with water helped to determine the crack pattern.

P12 AFTER SPRAYING WITH WHITE PAINT SURFACE
CRACK SHOWS IN CORE SAMPLE

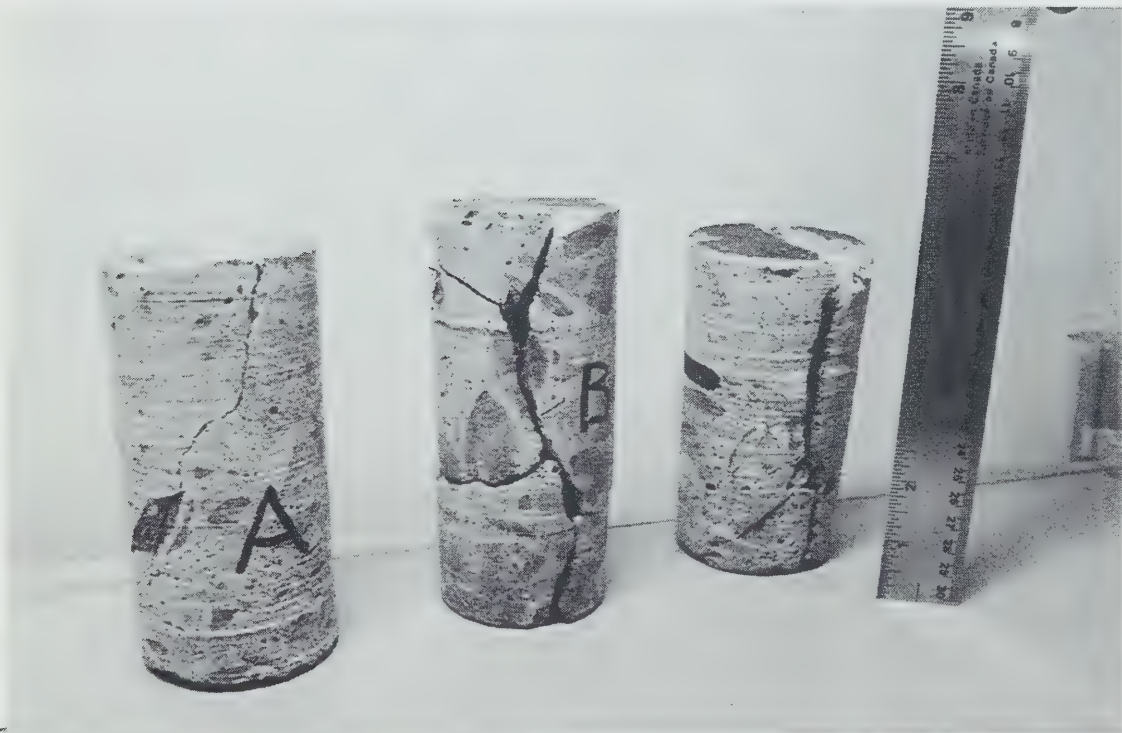
A coring machine was used to take samples through both longitudinal and transverse cracks to ensure full depth cracking was achieved. Generally, a crack observed on the surface of the roadway did continue through to the sub-grade. In one instance, it was initially thought that the crack did not extend through the roadway but after the core sample had been exposed to water it could be seen that the crack did indeed extend through the sample. One core sample showed that undesirable lateral cracking had also extended through the slab. (P13)

P13 CORE SAMPLES ILLUSTRATE EXTENT OF CRACKING
(SAMPLE B ILLUSTRATES UNDESIRABLE LATERAL CRACKING)

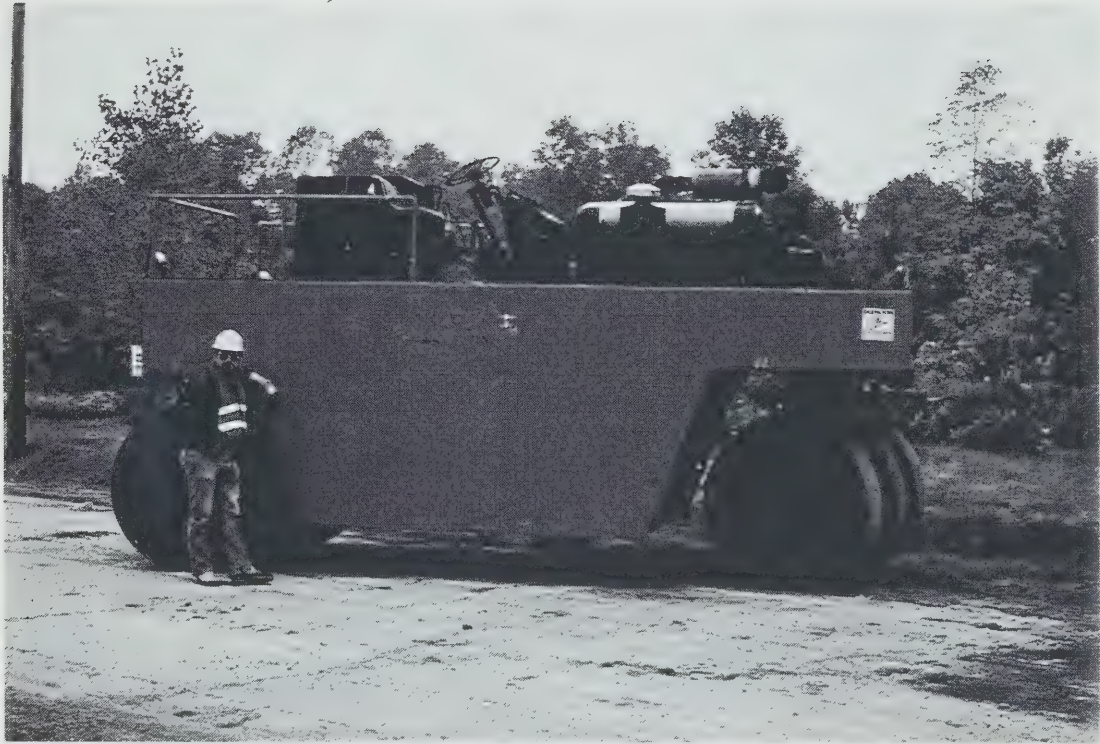
A thirty-five ton rubber-tired Gallion roller was used in the seating operation. (P14) The fully ballasted roller made four passes over each lane of the roadway. Two passes were made adjacent to the shoulder and two passes adjacent to the centreline.

P14 35 TON PNEUMATIC RUBBER TIRED ROLLER

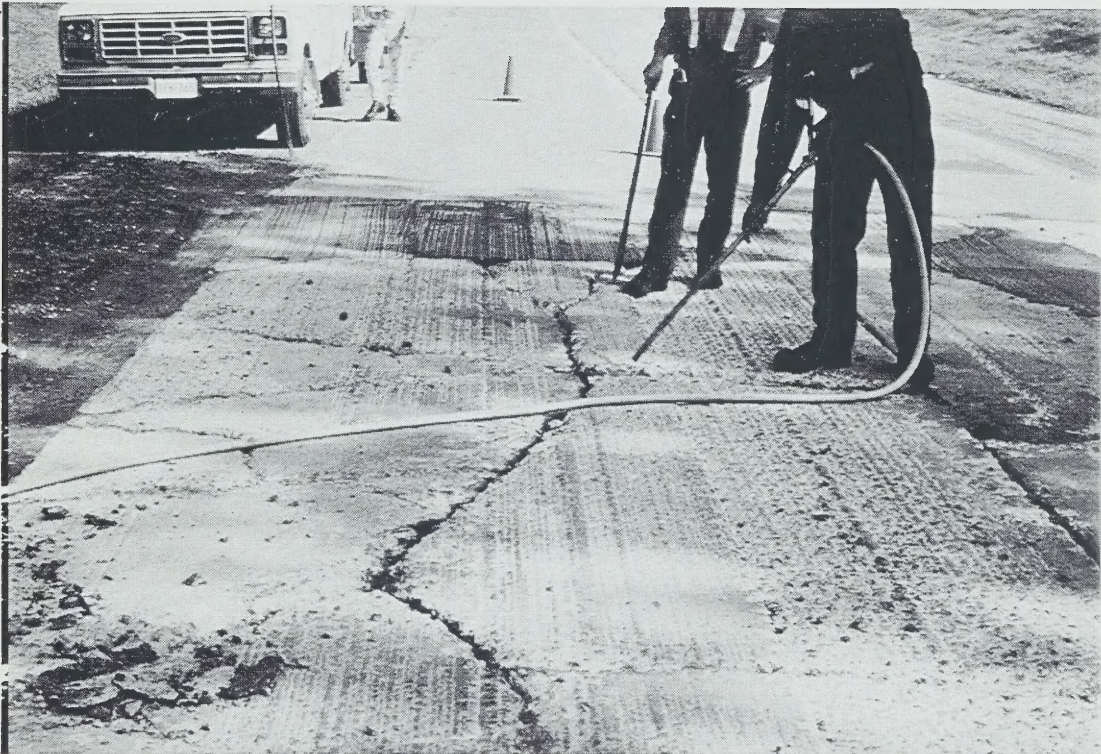
P15 CLEANING OF CRACKED CONCRETE PRIOR
TO SEALING WITH ASPHALT

All major cracks (i.e. cracks that existed prior to the cracking operation) measuring approximately 1.25 centimetres (1/2 inch) or greater were thoroughly cleaned using brooms and compressed air. (Pl5) A tack coat was then applied to the cracks and asphalt was placed and rolled to seal the cracks. Any spalled concrete was also removed and repaired at this time. On October 5, following a heavy rainfall on October 4, the resurfacing crew moved on site and applied a tack coat and the levelling course of HL3 asphalt with a maximum thickness of approximately 25 millimetres (1 inch). On October 8 through 9 the base asphalt consisting of 50 millimetres (2 inches) of HL8 was applied. Then on October 12, 40 millimetres (1 1/2 inches) of HL3 was applied as the final top coat.
